NEAR-MISS REPORT: SERVICE PULL-OUT

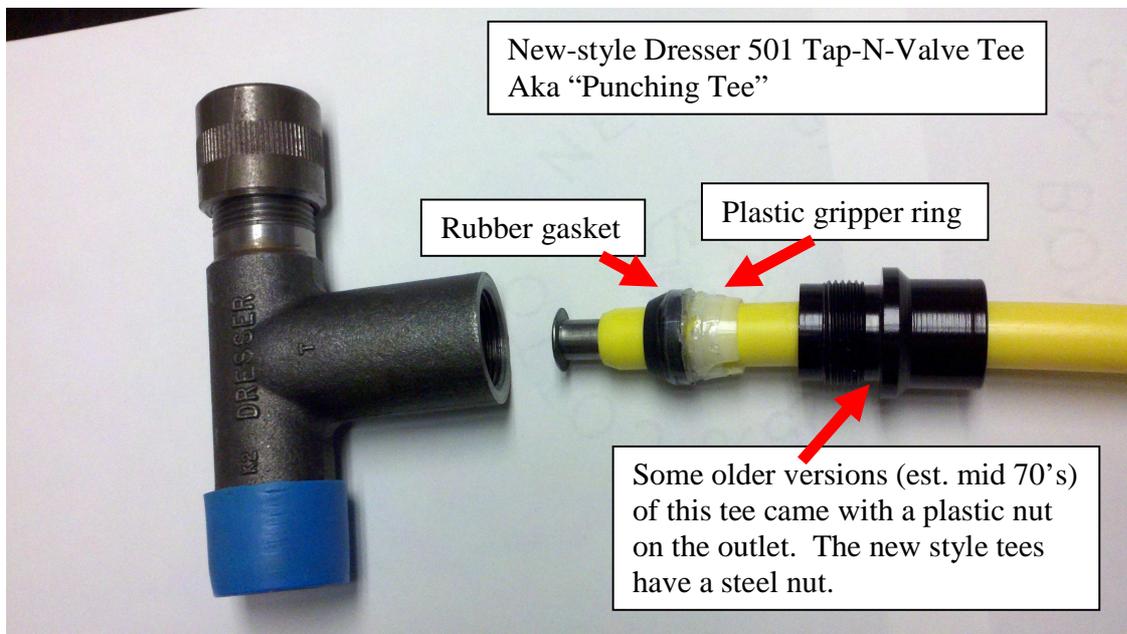
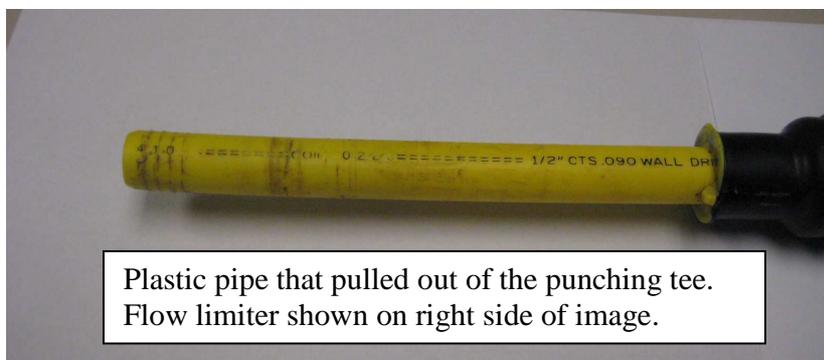
When the crew renewed the service after the line hit, they chose to disassemble the outlet of the punching tee which included a metal insert, plastic gripper, rubber gasket, and a plastic nut. When they attempted to join the new plastic to the outlet of the punching tee, they discovered that the threads on the plastic nut were stripped. They attempted to substitute a steel nut from a new style punching tee but the thread pattern did not match the old style tee that was on the main. A nut with a matching thread pattern from a used Dresser GTO valve was found in the scrap at their shop. This nut was steel and about 3" long compared to the original nut which was plastic and about 1" long. The nut appeared to be compatible so the crew completed the joint using the steel nut. This is the joint that failed and caused the emergency condition.

1. The components of the failed joint were not available for inspection during the root cause analysis, however the Training Department was able to re-create the joint by using other components similar to those used in the field. Based upon the post-incident investigation, it appears the nut from the GTO valve was not compatible with the punching tee. This likely contributed to the service pull out.

3. There were no visible stab depth marks on the service tubing that pulled out of the punching tee. Either the stab depth was not marked, or the mark were worn off something other than a permanent marker was used to mark the depth.

Since the 3" long nut from the used Dresser valve has not yet been available for inspection, it is unclear if and how it factored in to the failure. It clearly made it more difficult to determine an accurate stab depth and was therefore at least a contributing factor to the incident.

1. Operations supervisors review details of this incident with all Operations employees. Emphasize the importance of following established procedures to ensure safe installation of components in the gas system.

2. Training Department to review procedures with Operations employees to follow when encountering old or obsolete fittings in the gas system. This review can be added to the annual mechanical fitting re-fresher training. In general, parts from used gas components should be used as a last resort on a kind-for-kind replacement basis only. For example, parts from a used curb valve should not be used to replace broken parts on a punching tee.
