## Near Miss Report

### 3<sup>rd</sup> Party Auger Near High Pressure Line

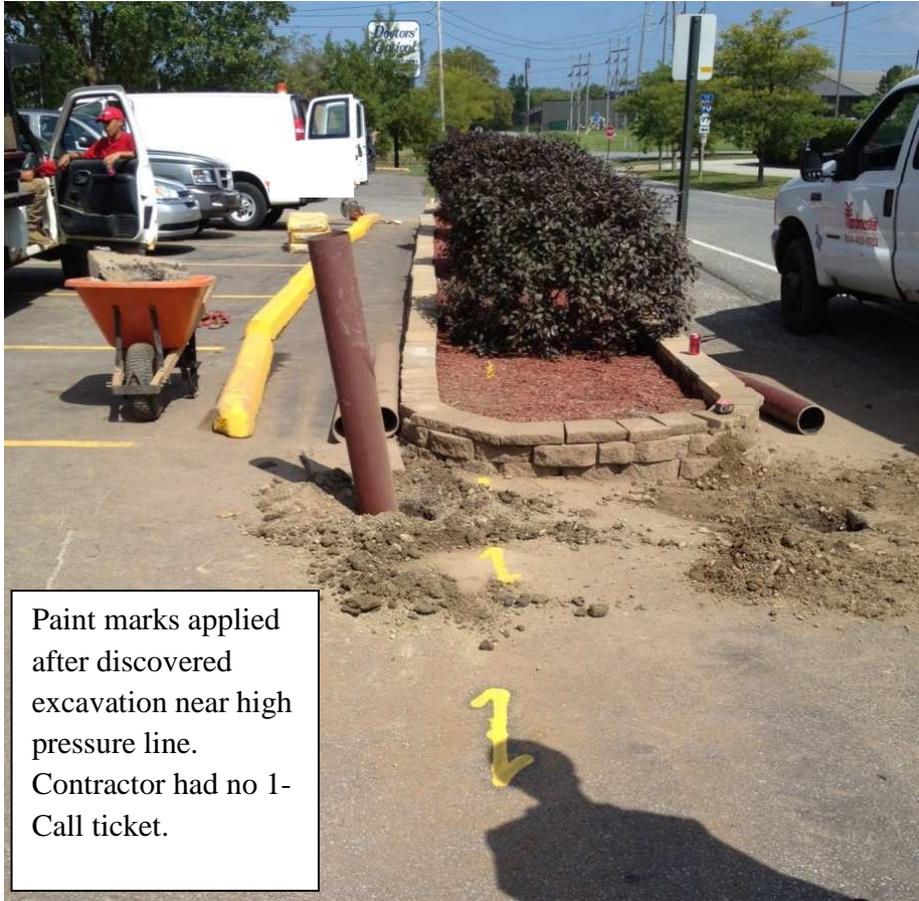
Paint marks applied after discovered excavation near high pressure line. Contractor had no 1-Call ticket.

Upon investigation it was determined that a PA 1-Call ticket had not been initiated by the contractor and they were indeed excavating illegally without marks. Their auger had narrowly missed the line, passing within 8 – 10” of the 360 psi steel line. When the local supervisor arrived, he successfully defended our right-of-way and convinced the contractor to remove the protection post.
