## Near Miss Report

### Company Contractor Damaged High Pressure Line

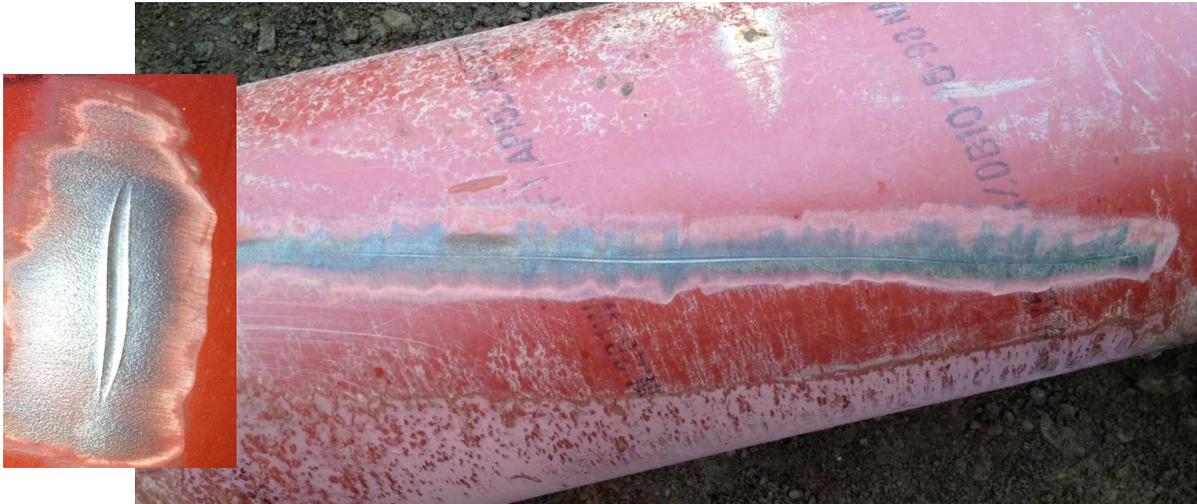
Serving as a construction inspector can be a challenging assignment particularly when inheriting a job that is in progress. During a hydrotest project on a 180 psig line, the primary inspector was away and was temporarily replaced by a different inspector. When the relief inspector arrived on the job site, he found the contractor had installed rock shield on the line and was prepared to backfill. Following good inspection procedures, he insisted the contractor remove the rock shield to permit examination of the line and coating. Upon inspection at least 2 significant scratches that penetrated both the coating and the metal on the pipe were detected and the scratches had to be ground out and repaired by a Company welder. If the inspector had not insisted the rock shield be removed and the line examined, the contractor would have backfilled the damaged line which could have resulted in a safety issue in the future.

This event serves as a good reminder of how important it is to follow operating procedures. The inspector who made the right decision in this circumstance was recognized by his co-workers for having the integrity to do the right thing in a difficult situation. By making the right call, he may have averted a future hazard that could have resulted from accelerated corrosion where the pipe was damaged.
